# PHENIX WEEKLY PLANNING

TECHNICAL  
SUPPORT  
2011

7/28/2011  
Don Lynch

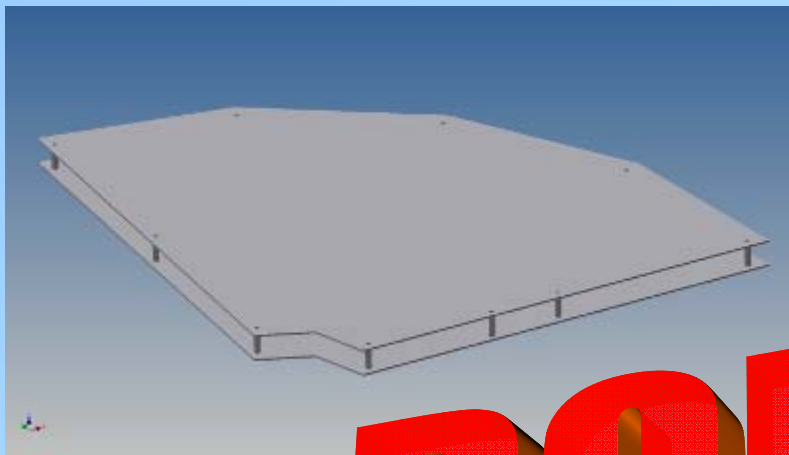
Station 2 access (MMS shown  
MMN is similar)

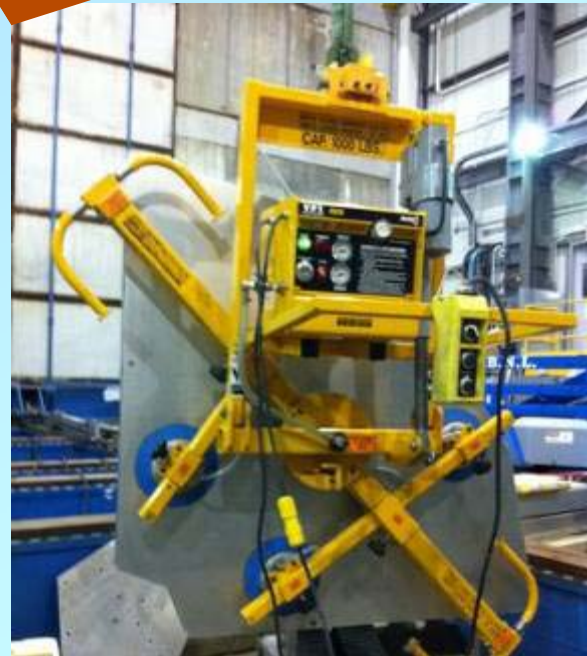
Dummy MuTr Station 1 Octant. Will be used to re-qualify vacuum lifting fixture and to practice using vacuum lifting fixture prior to removing station 1 north octants.

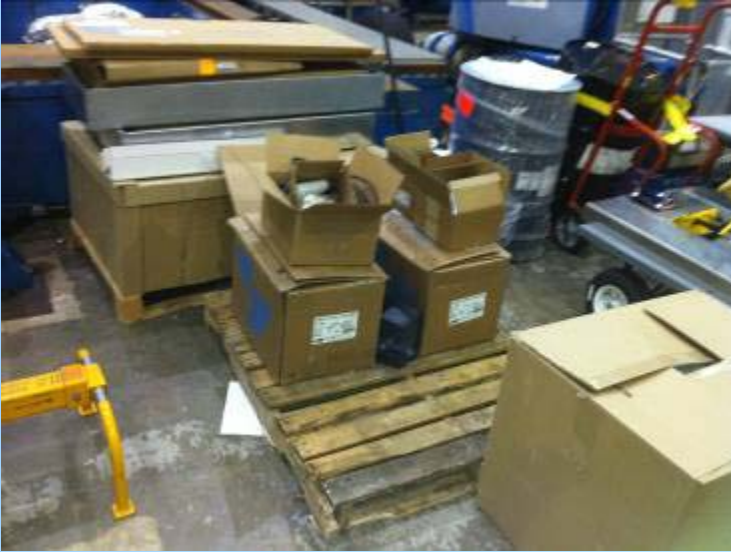
IR Crane 1 ton replacement parts received. Paul and Mike R. planning for upgrade work, test complete

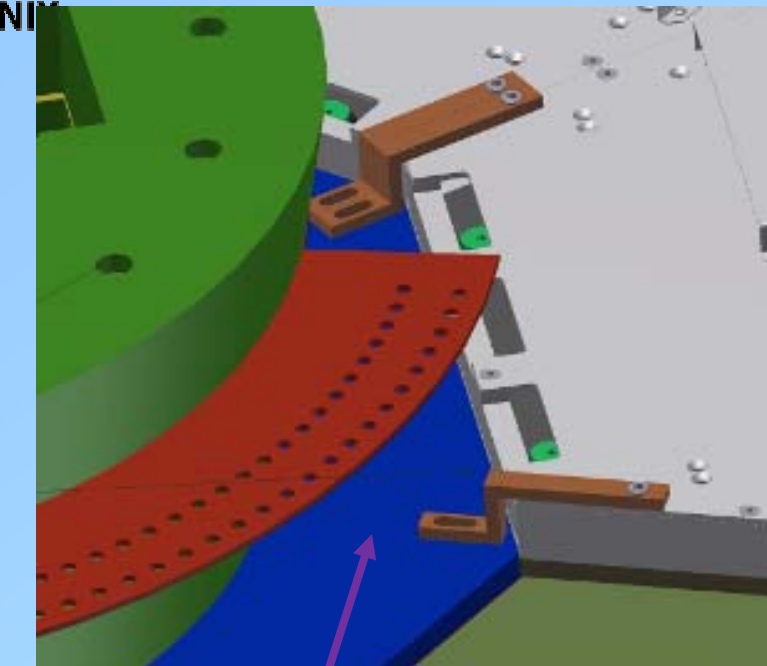
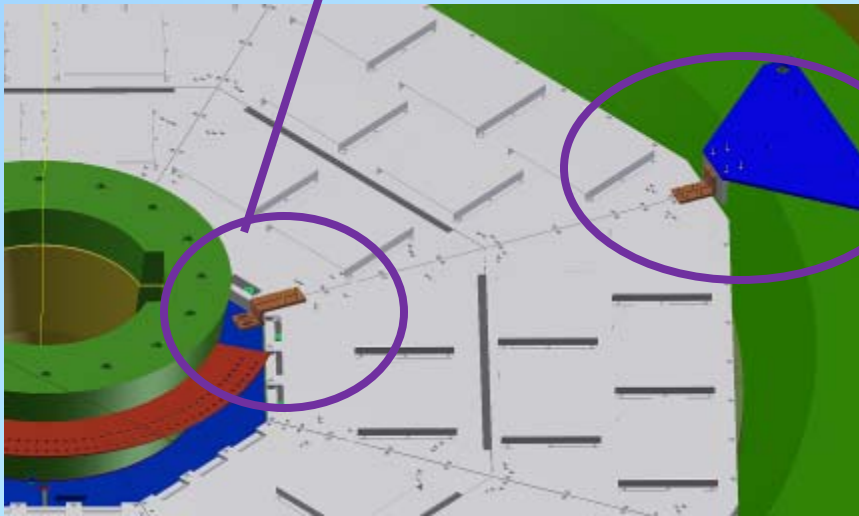
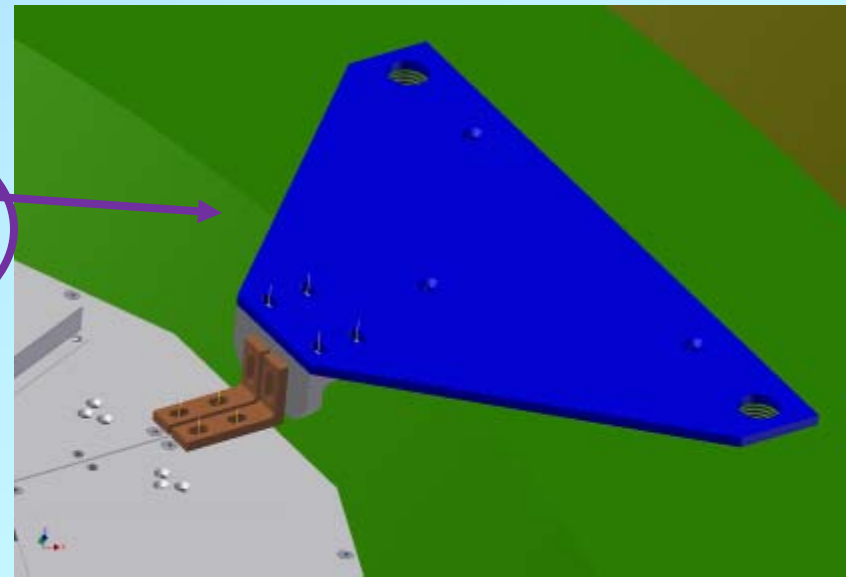
## RPC1 Mounting Concept

Octants are individually mounted then tied together and supported at the outer octant boundaries by brackets mounted on existing tapped holes, and on inner edges by rings which wedge against the flower pot lead liner. Tapped holes in 8 places on each octant are used both to mount the absorber section and to attach the mounting brackets.

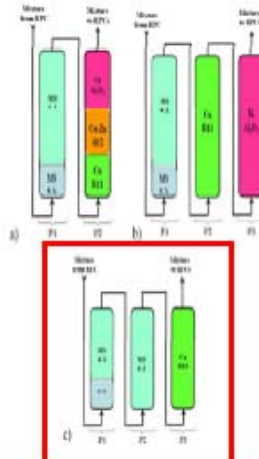
Possible RPC purifiers'  
configurations: a)  
configuration currently  
used at the LHC  
experiments, first b) and  
second c) optimized  
configurations

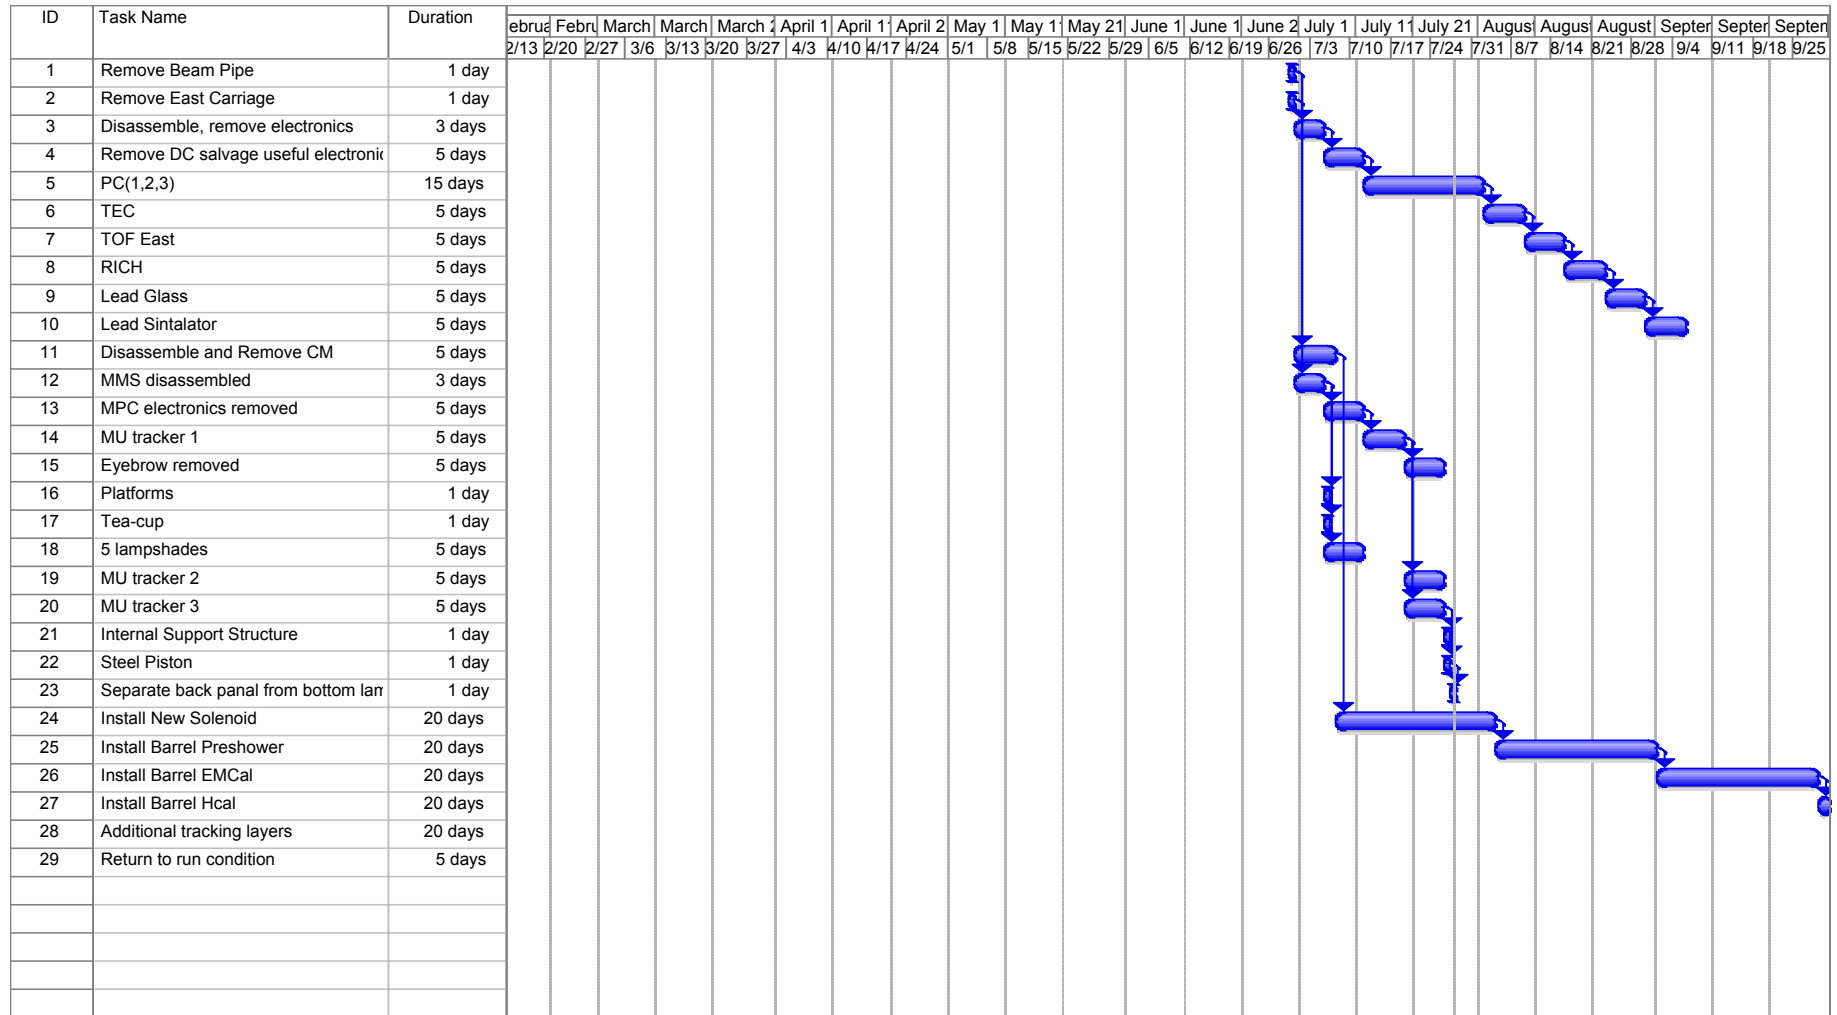
# 1st Period

About 5 months of work

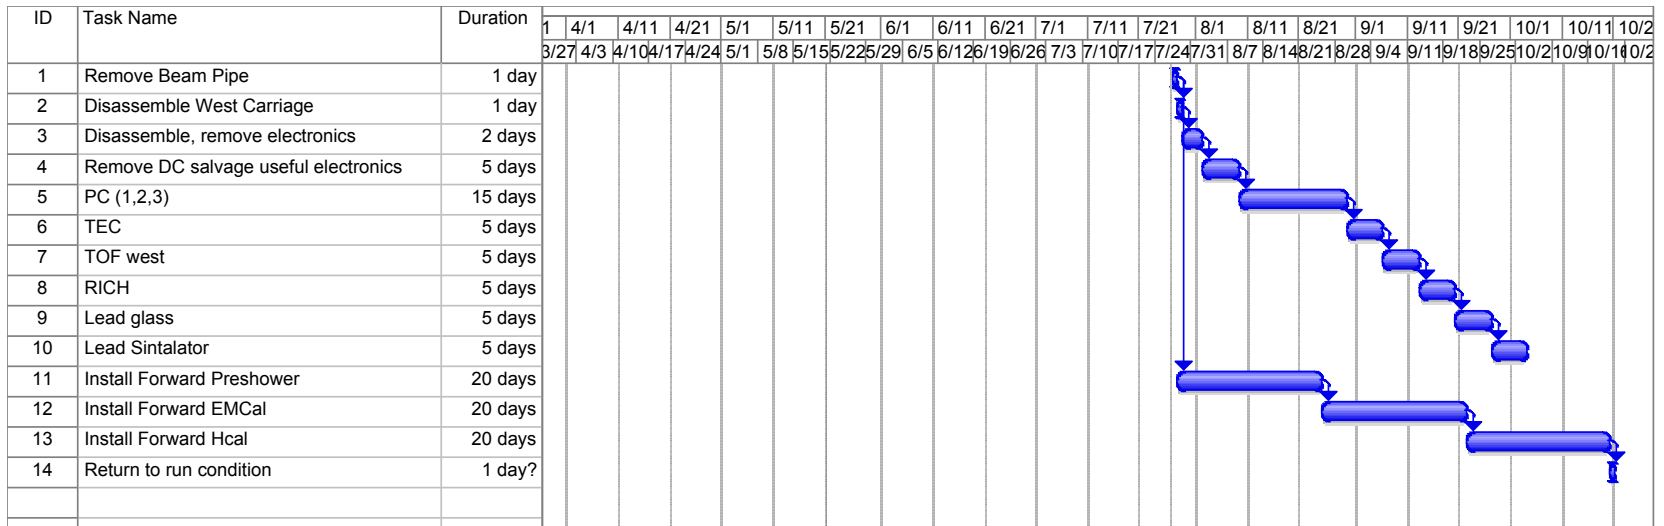
## 2<sup>nd</sup> Period

Only 3 months of work

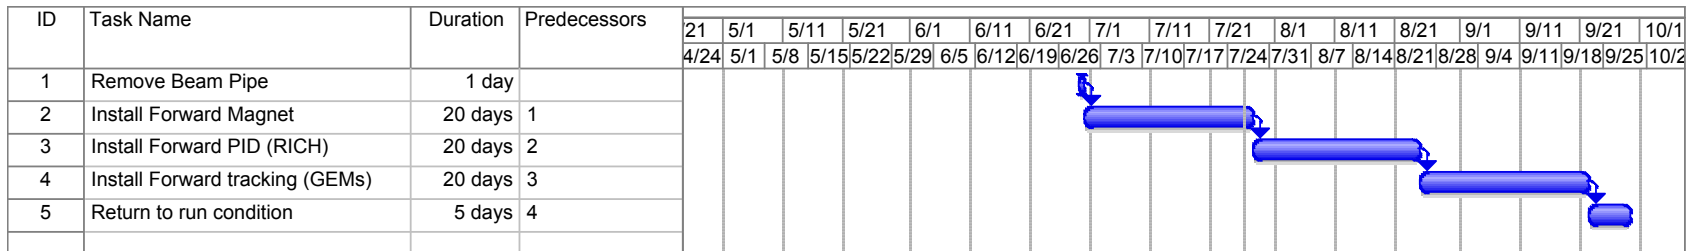
## 3<sup>rd</sup> Period

Only 3 months of work
